DEPARTMENT OF TRANSPORTATION

Quality Assurance and Source Inspection

Contract #: 04-0120F4Cty: SF/ALA Rte: 80 PM: 13.2/13.9File #: 69.28**WELDING INSPECTION REPORT****Resident Engineer:**Siegenthaler, Peter**Address:** 333 Burma Road**City:** Oakland, CA 94607**Report No:** WIR-022076**Date Inspected:** 31-Dec-2010**Project Name:** SAS Superstructure**OSM Arrival Time:** 700**Prime Contractor:** American Bridge/Fluor Enterprises, a JV**OSM Departure Time:** 1900**Contractor:** Zhenhua Port Machinery Company, Ltd (ZPMC), Changxing Island **Location:** Shanghai, China**CWI Name:** Qiu Wen**CWI Present:** Yes No**Inspected CWI report:** Yes No N/A**Rod Oven in Use:** Yes No N/A**Electrode to specification:** Yes No N/A**Weld Procedures Followed:** Yes No N/A**Qualified Welders:** Yes No N/A**Verified Joint Fit-up:** Yes No N/A**Approved Drawings:** Yes No N/A**Approved WPS:** Yes No N/A**Delayed / Cancelled:** Yes No N/A**Bridge No:** 34-0006**Component:** OBG**Summary of Items Observed:**

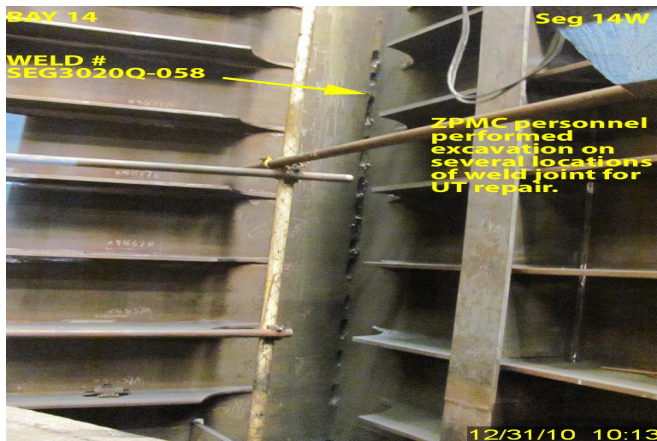
During random in process inspection this QA inspector observed that ZPMC personnel performed excavation on 17 different locations on the weld joint SEG3020Q-058 joining Floor Beam (FB) 3320a to Longitudinal Diaphragm (LD) 3049 at Panel point (PP) 126. This weld joint was rejected and marked on several locations by ZPMC NDT personnel during Ultrasonic Testing (UT). Attached photograph provide additional detail.
